Elastomeric Roofing Systems, Inc.

To:
Company:
Fax:
Subject: Hail Damage Report

In June of 1998, this PVC membrane was restored using Eraguard 1000 white acrylic coating (average coating thickness of 18 mils dry) with a full primer coat in Denver, CO. All seams were reinforced using fabric faced butyl tape. At the time of the roof restoration, the membrane age was estimated at 11 years old.

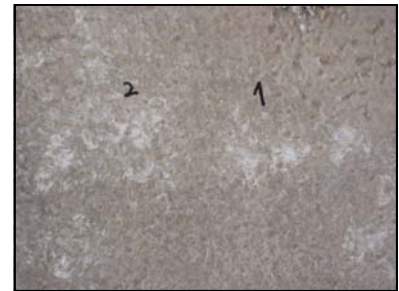
In the spring of 2004, the roof went through a significant hail storm. A 3 ft by 4 ft section of the PVC roofing membrane was removed for analysis. Figure 1 shows the witness marks of the hail strikes on the surface of the top coating. Figure 2 shows the backside of the membrane and the damaged done to the PVC in the same location as Figure 1. The size of the strike damage ranged from very small to as large as 2" in diameter. On average, there were over 10 strikes per ft² on the sample. 95% of these strikes damaged both the top and bottom layers of the membrane as shown in Figure 3.

Figure 1 - Witness marks on Surface of Topcoat

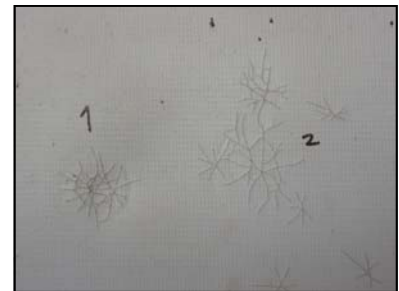
Figure 2 - Damage on Backside of Membrane

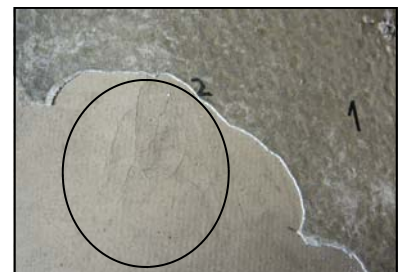
Figure 3 - Damage to surface of membrane with coating removed

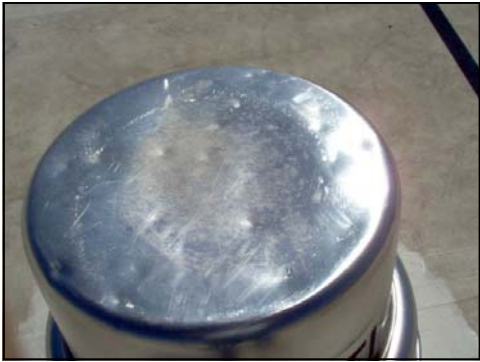
Although there was significant damage to metal roof top HVAC units and vents (Figure 4), the coated top surface of the membrane showed no damage, only witness marks.

Figure 4 - Damaged Vent

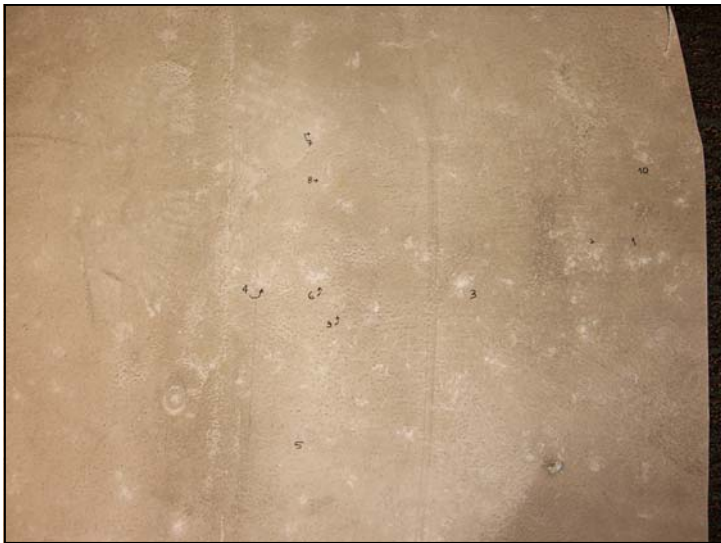
Figure 5 - Witness marks on Surface of Topcoat

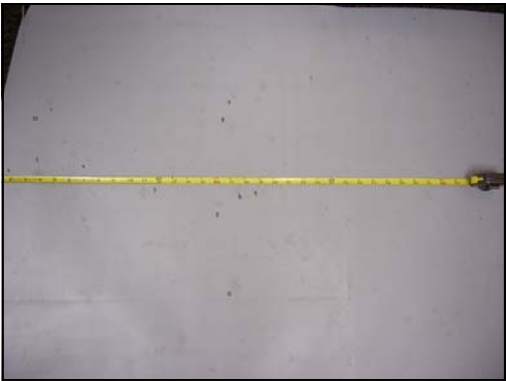
Figure 6 (Left) - Damage on back of membrane sample

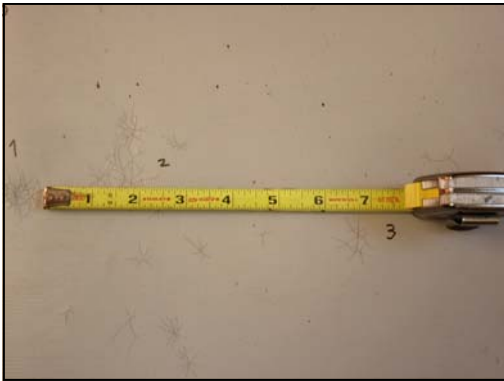
Figure 7 (Right) - Close up of damage on the back of membrane sample
